BF 73649 E/W Bridge Culverts Highway 15 Crossing Astotin Creek

Bridge Culvert Assessment Report

PROJECT N° E025 E00311A
November 26, 2012

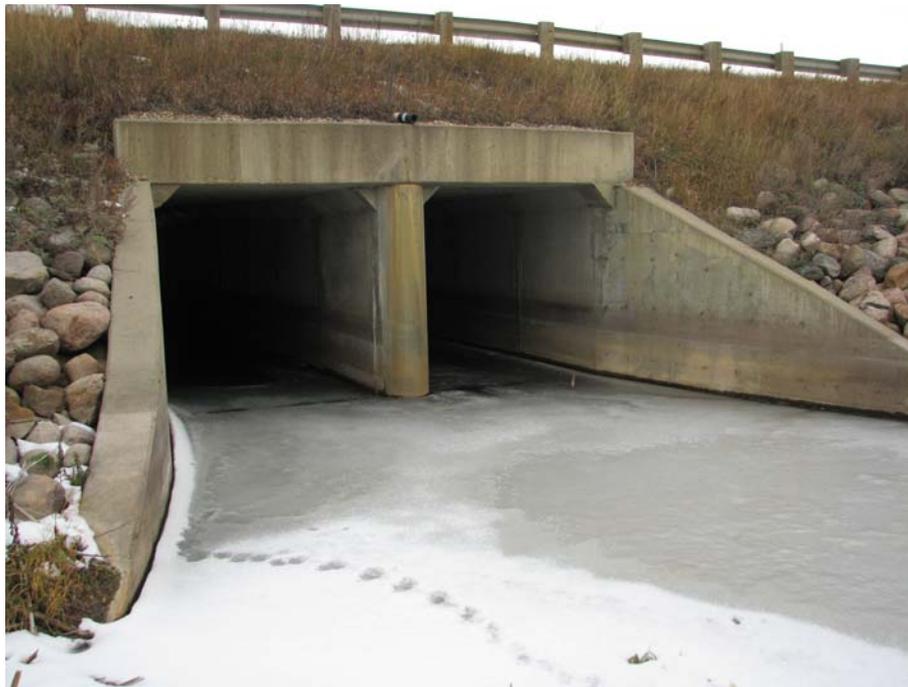
There were no deficiencies observed within the boxes observed. However, some hairline to wide cracks were observed on the concrete headwalls and wingwalls at the upstream and downstream ends. On the most recent BIM, the upstream and downstream culvert ends have been rated '6' and '7' respectively. The headwall and wingwalls are considered to be functioning as intended; as such, no repairs to these cracks are warranted at this time.

Photo: IMG_7815.JPG
Taken: 2012/11/06 10:19:43
Description: Looking north towards upstream end of BF 73649W, note vertical crack in center of headwall.

No repairs to this structure are warranted at this time. It is recommended to continue with regular programmed BIM inspections. And should the condition of the structure significantly change, the culvert should be reassessed at that time to determine an appropriate strategy.

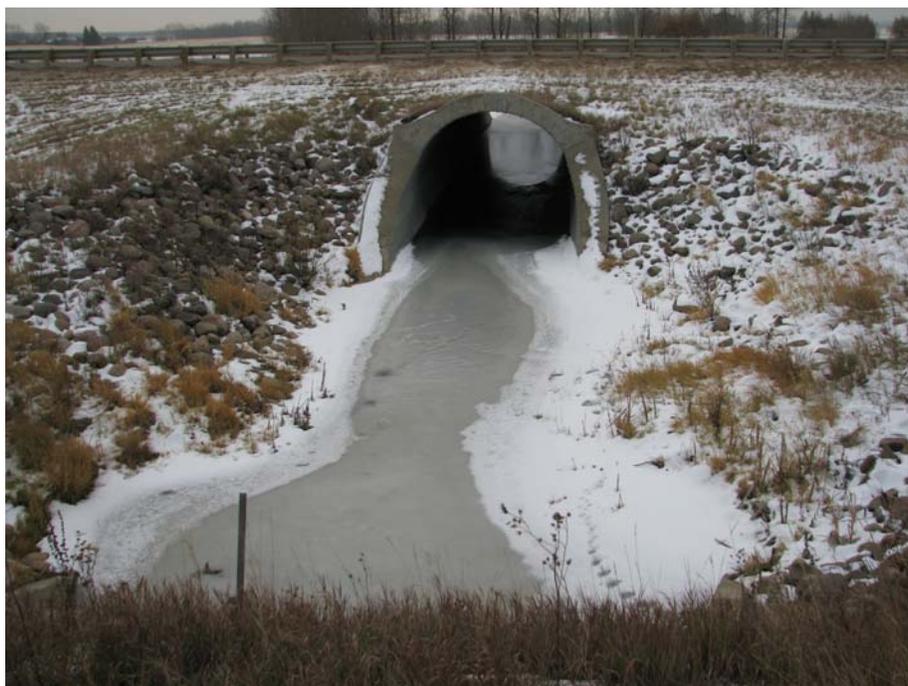
Photo: IMG_7817.JPG
Taken: 2012/11/06 10:22:16
Description: Looking south towards downstream end of BF 73649E in median.

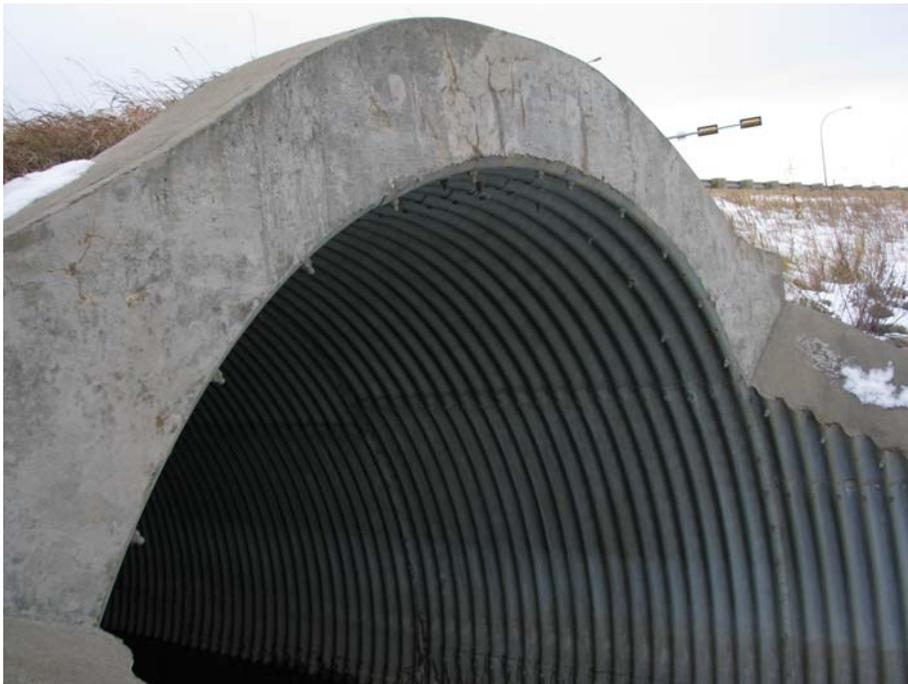
The upstream and downstream culvert ends have been rated '6' and '7' respectively. Transverse hairline cracking was observed on both collars, while the most recent BIM also reported that wide cracks were observed on the upstream collar. The collar is considered to be functioning as intended; as such no repairs to these cracks at this time are warranted.

Photo: IMG_7823.JPG
Taken: 2012/11/06 10:35:34
Description: Looking south west towards downstream end of BF 73649E collar.

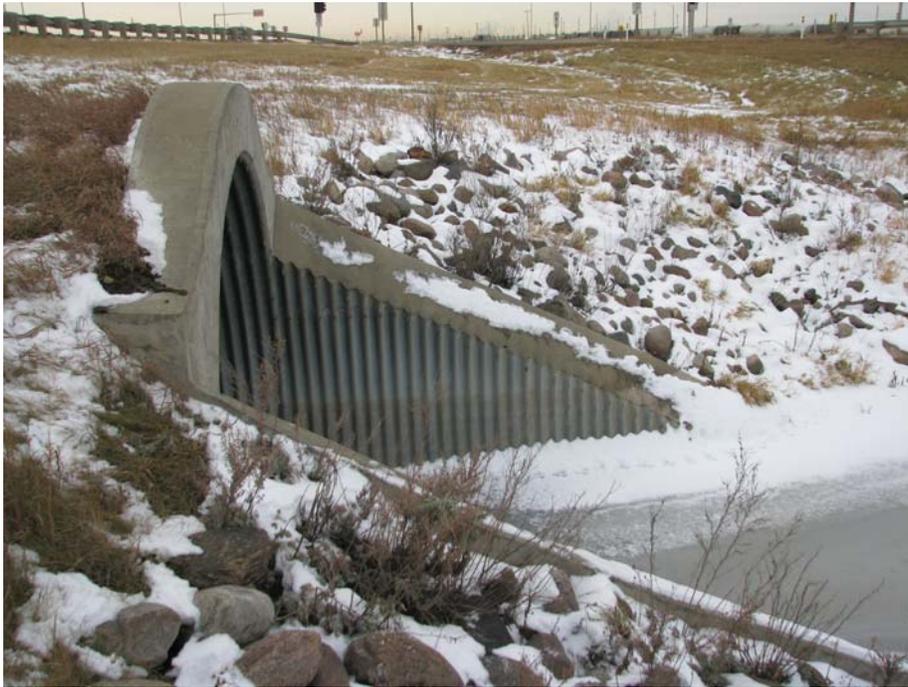
Photo: IMG_7824.JPG
Taken: 2012/11/06 10:35:52
Description: Looking west towards BF 73649E downstream end (in median).

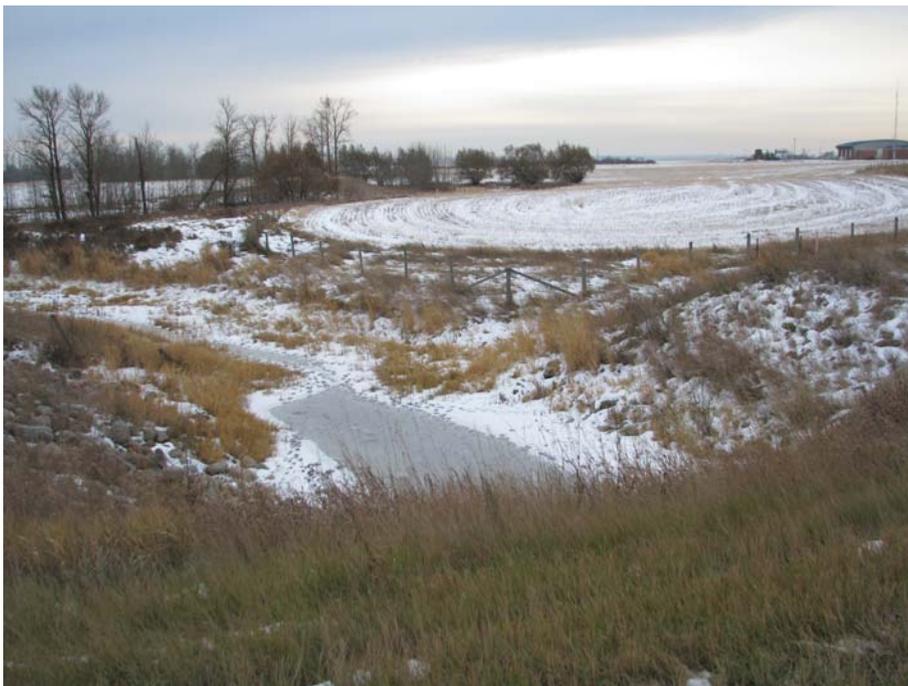
Photo: IMG_7826.JPG
Taken: 2012/11/06 10:37:19
Description: Looking south at upstream of BF 73649E.

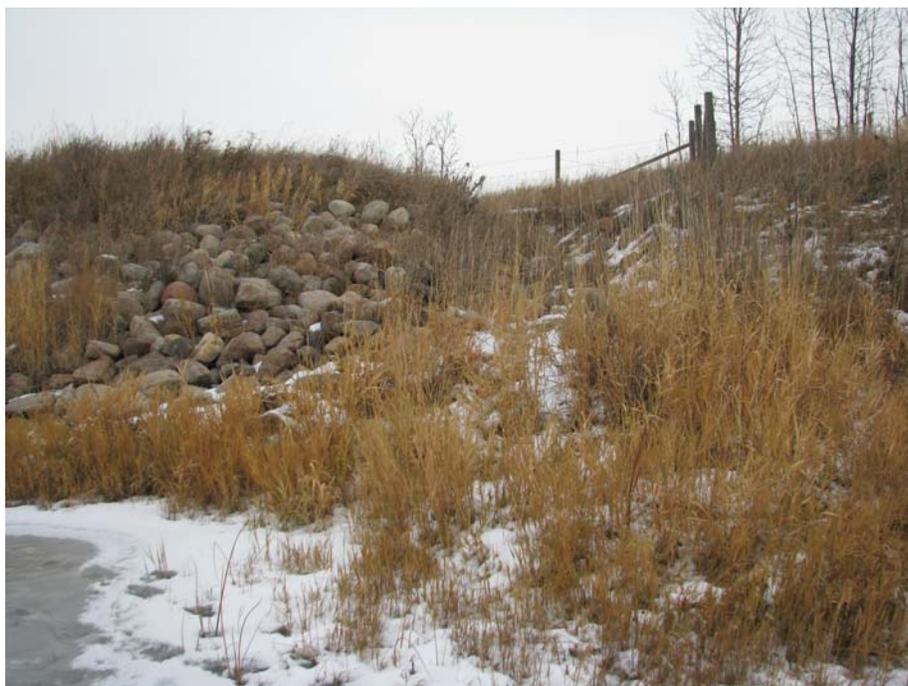
The design summary reports the design flow as 32 m³/s.
2008 BIM first reports that erosion is observed southeast of the upstream end. Based on a review of file information, there is no indication of hydrotechnical issues at this site. As such, **hydrotechnical issues are not considered a controlling factor** for this assessment report. When the structure requires replacement, a further hydrotechnical study would be recommended.

Photo: IMG_7828.JPG
Taken: 2012/11/06 10:51:46
Description: Looking east at gully forming southeast of BF 73649E.

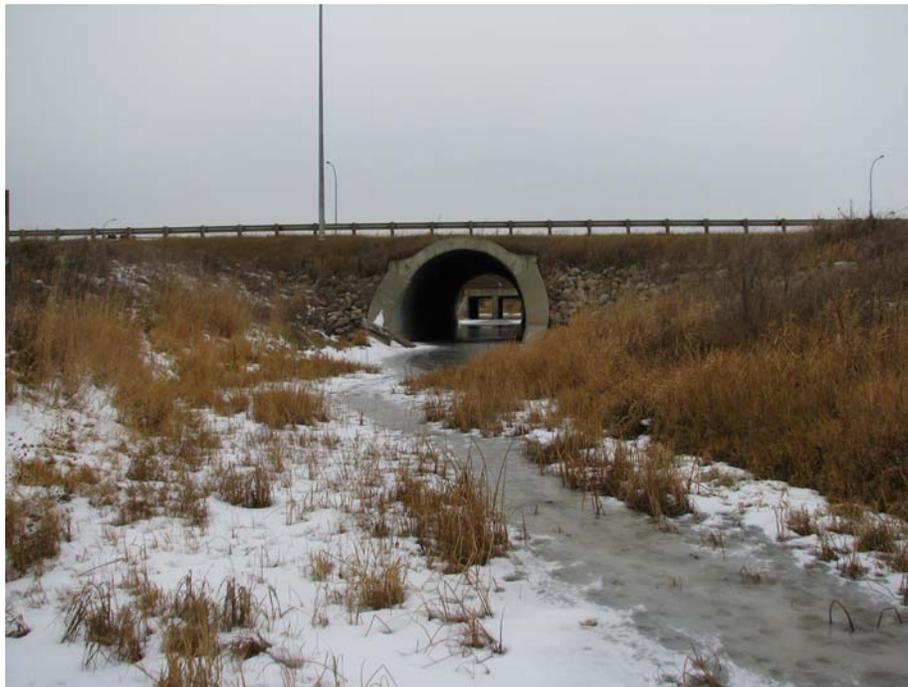
Photo: IMG_7829.JPG
Taken: 2012/11/06 10:52:47
Description: Looking north at upstream end (south end), of BF 73649E.

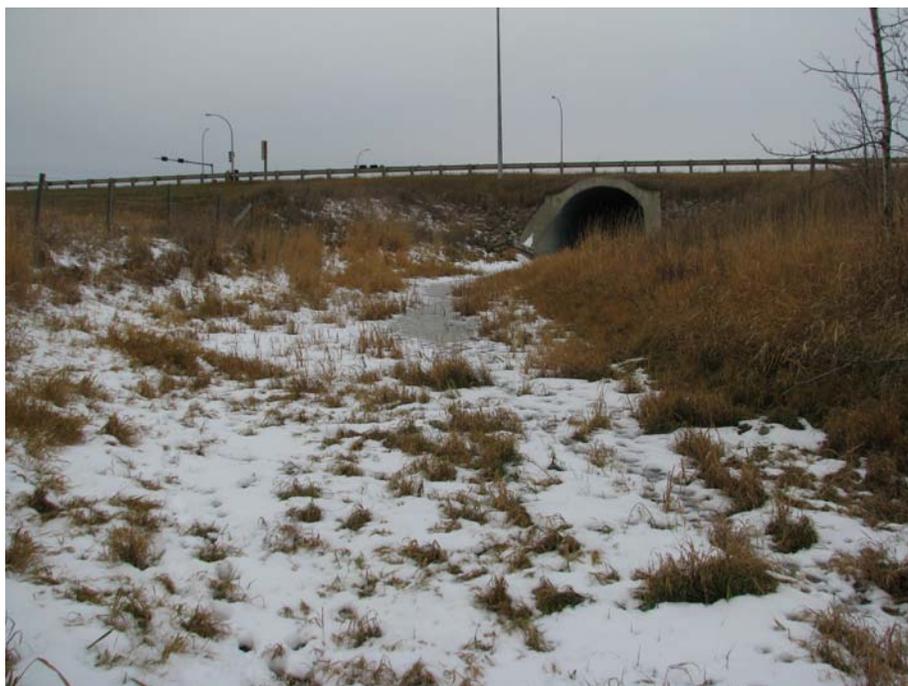
Photo: IMG_7831.JPG
Taken: 2012/11/06 10:53:09
Description: Looking north towards upstream end of BF 73649E.

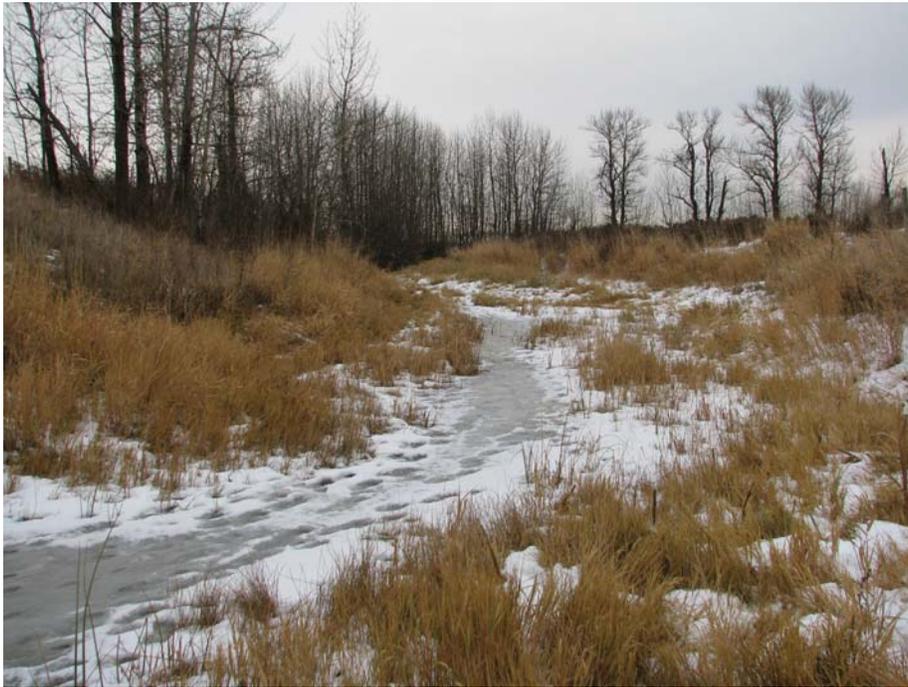
Photo: IMG_7832.JPG
Taken: 2012/11/06 10:56:01
Description: Looking south towards upstream of BF 73649E.

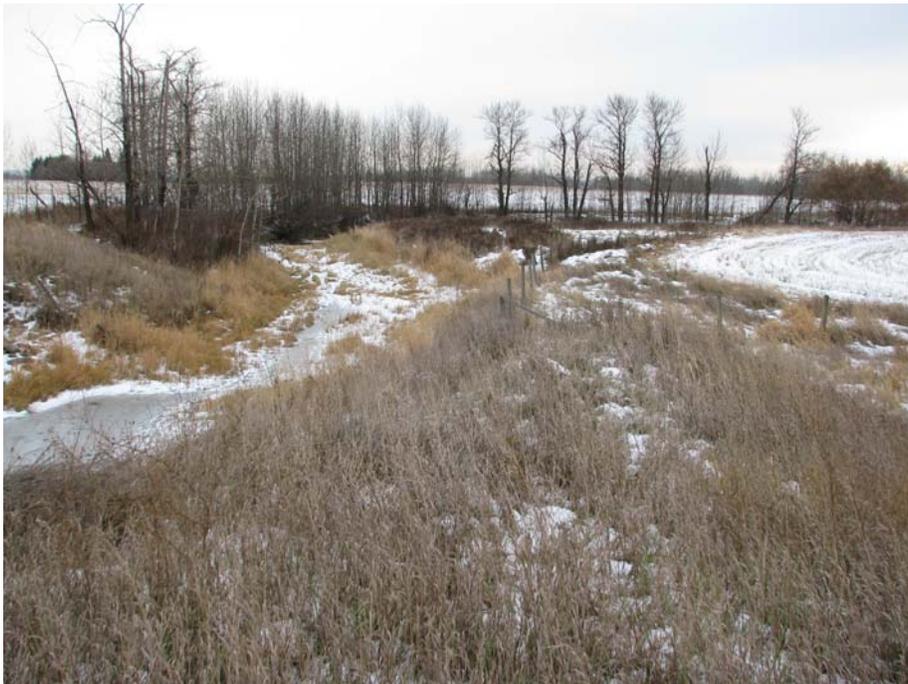
Photo: IMG_7833.JPG
Taken: 2012/11/06 10:57:20
Description: Looking south east towards upstream of BF 73649E.

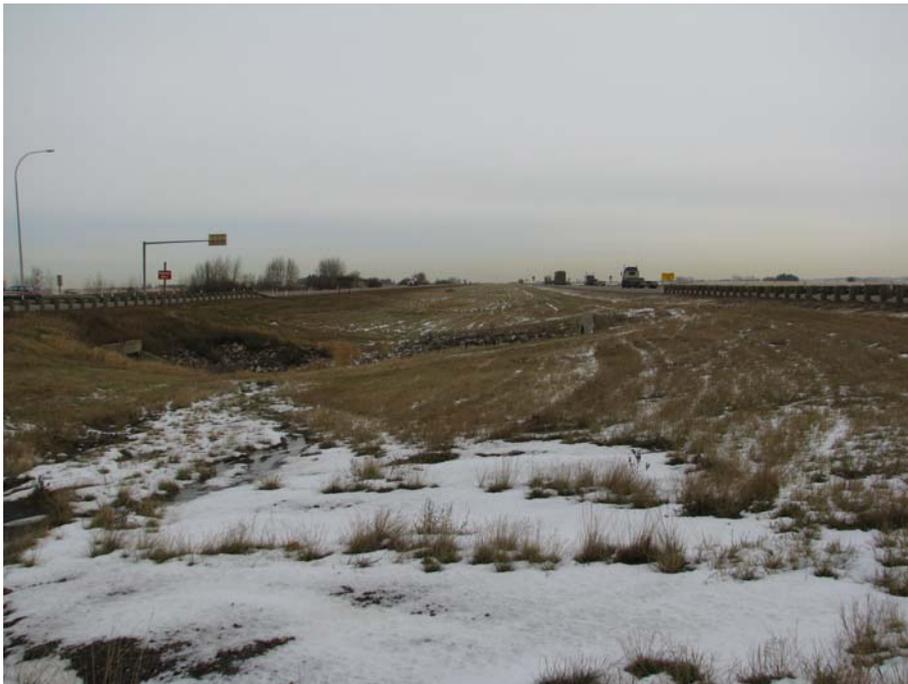
Description: Looking east towards downstream end of BF 73649E and upstream end of BF 73649W within Highway 15 median.

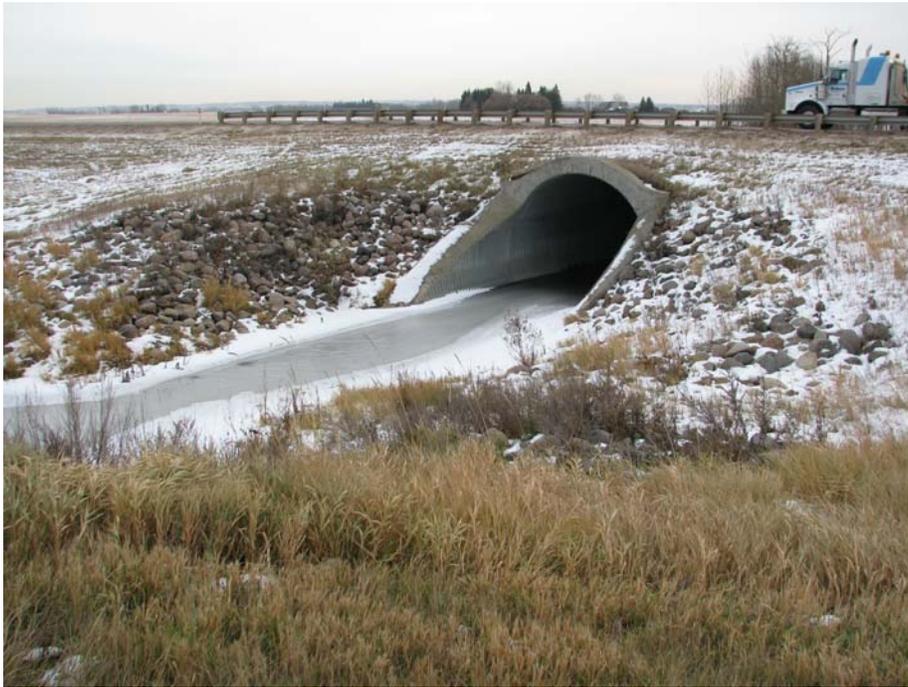
Description: Looking southeast towards downstream end of BF 73649E within median.

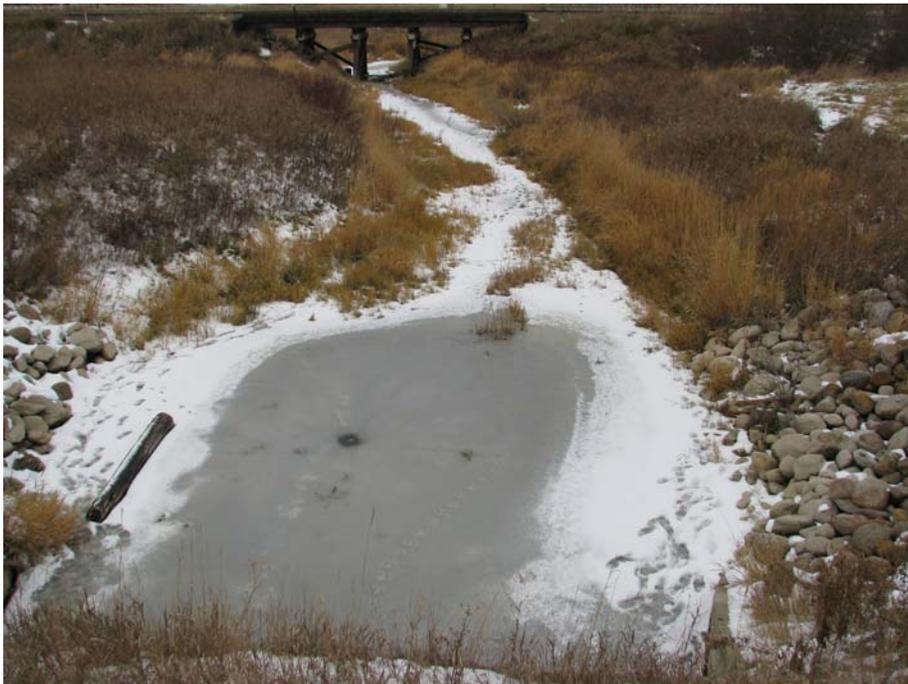
Description: Looking north at downstream end of BF 73649W.

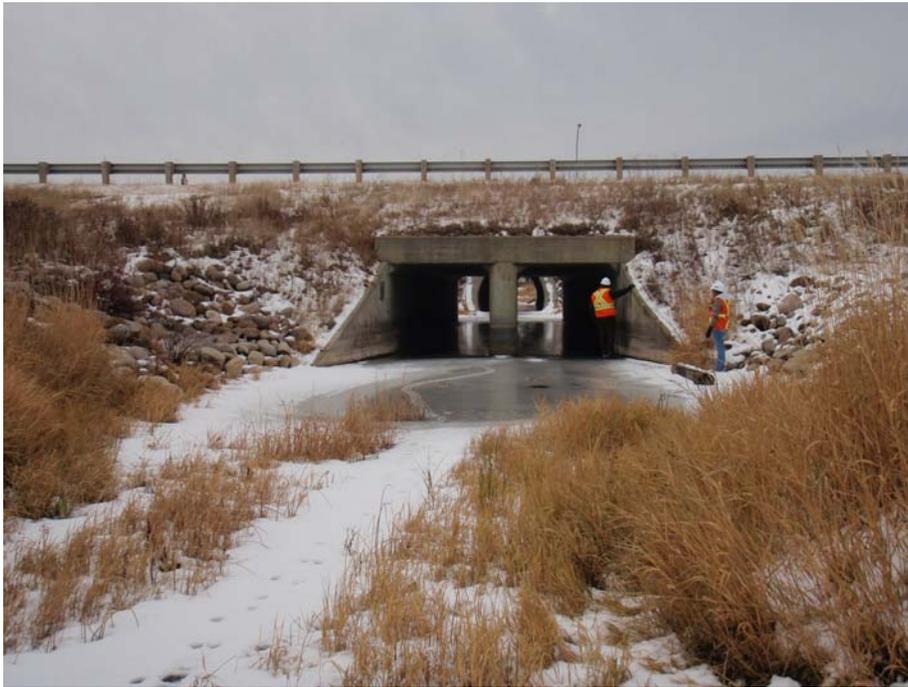
Photo: PB061519.JPG
Taken: 2012/11/06 10:02:07
Description: Looking south towards downstream end of BF 73649W.

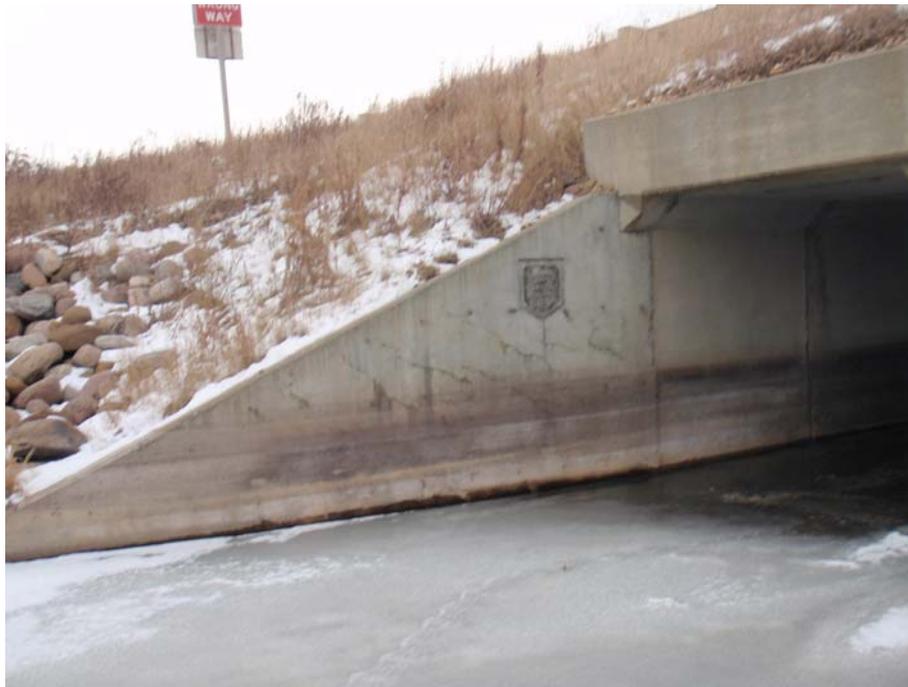
Photo: PB061521.JPG
Taken: 2012/11/06 10:04:34
Description: Looking east at northeast wingwall of downstream end of BF 73649W, note diagonal cracking.

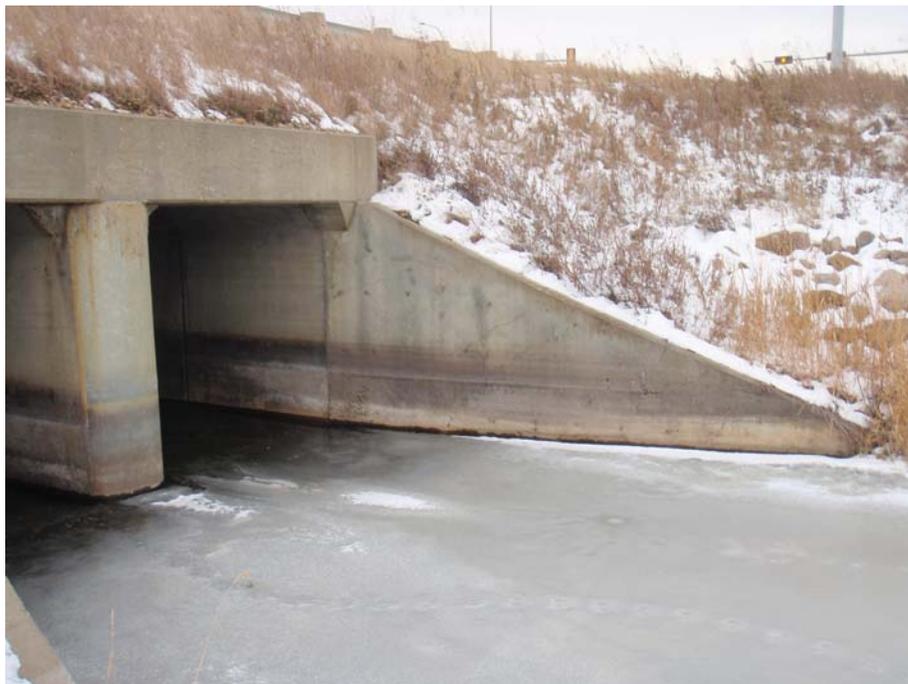
Photo: PB061523.JPG
Taken: 2012/11/06 10:08:46
Description: Looking west towards northwest wingwall of downstream end of BF 73649W.
