Encl. Astotin Creek Resiliency Study: State of the Watershed

State of the Watershed June 2022

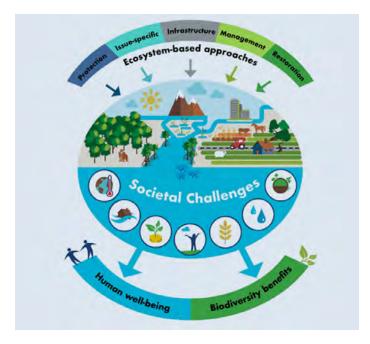
Figure 1-2: Ecological Resiliency and Benefits through Nature-based Solutions (UCN, 2019)

This report, the 'State of the Watershed' study, assessed the current capacity of the Astotin Creek watershed to provide the ecological goods and services (EGS) that sustain current land use in the area. An EGS perspective can be helpful to resiliency planning, by describing the condition of 'natural capital' such as clean air and water, recreational opportunities, and flood and drought protection that is valued, but not always broadly recognized by area residents. By assessing the relative health of aquatic and terrestrial ecosystems, we can help identify risks, or 'tipping points' that will ultimately affect ecological resiliency of an area and the quality of life now enjoyed by its residents. The International Union for Conservation of Nature (IUCN, 2019) has acknowledged the link between human well-being and ecological health and recommends nature (ecosystem)-based solutions to address community needs and challenges. An EGS focus can help identify resiliency solutions that sustain communities and the environment (Figure 1-2).

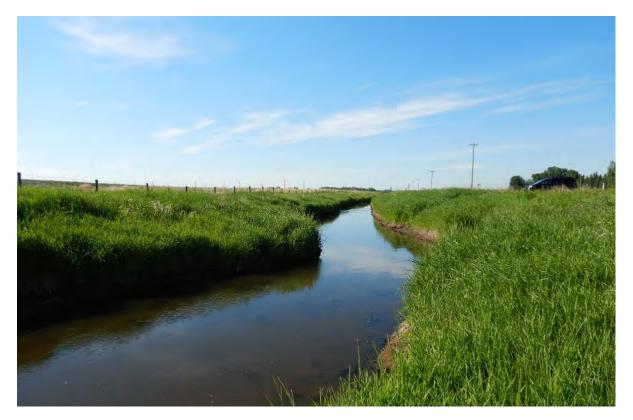
Figure 4 -3 Channelized Section of Astotin Creek

Field survey found the creek was channelized between stations 10 km and 11.6 km with an approximate bottom width of 1-3 m and bankfull width of up to 8 m. The creek was also channelized between stations 24 km and 26.4 km, with an approximate average bottom width of 1-4 m and bankfull width of up to 10 m. The side slopes varied from almost 1:2.5 to almost flat along the creek at these locations. Figure 4-3 shows an example of a channelized section of Astotin Creek.
