BF 73649 E/W Bridge Culverts Highway 15 Crossing Astotin Creek

Bridge Culvert Assessment Report

PROJECT N° E025 E00311A
November 26, 2012

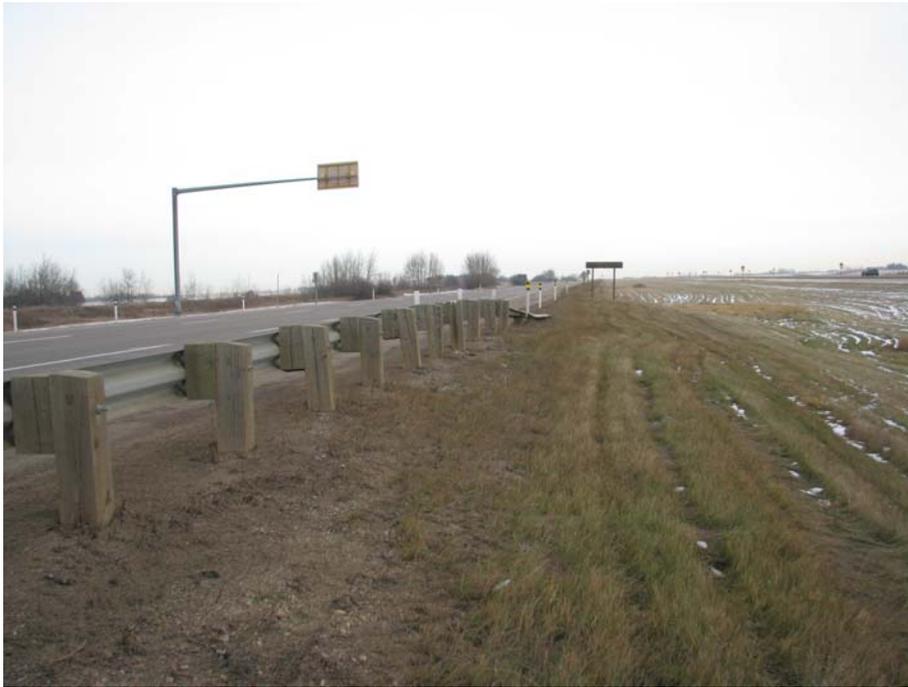
Photo: IMG_7818.JPG
Taken: 2012/11/06 10:24:03
Description: Looking east along south guardrail of Highway 15 west bound lanes.

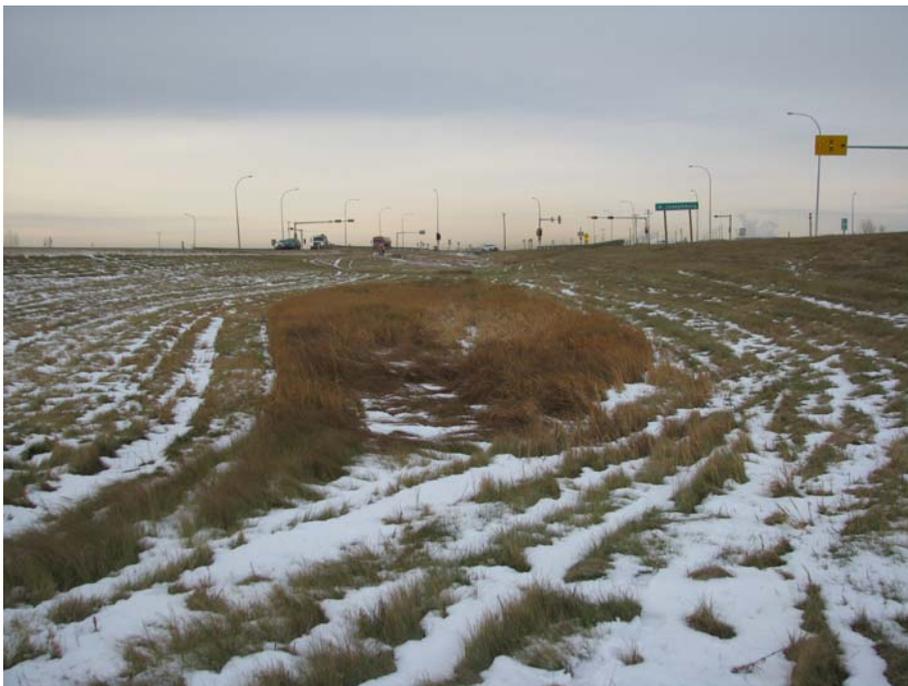
Photo: IMG_7819.JPG
Taken: 2012/11/06 10:26:57
Description: Looking east at Highway 15 median, approximately 150 m east of BF 73649 E/W location.

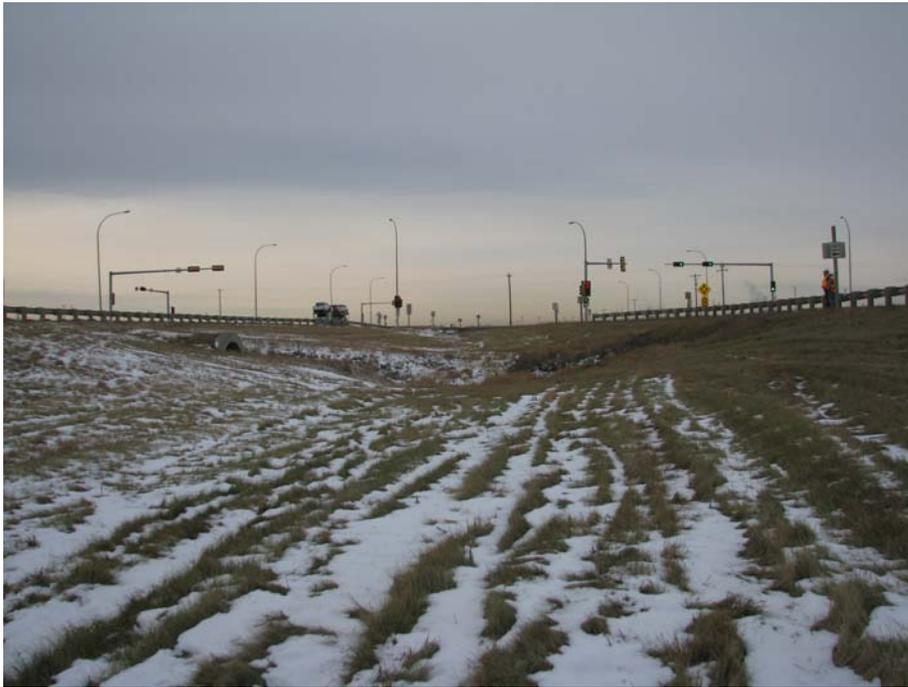
Photo: IMG_7821.JPG
Taken: 2012/11/06 10:29:01
Description: Looking west towards BF 73649 E/W in median.

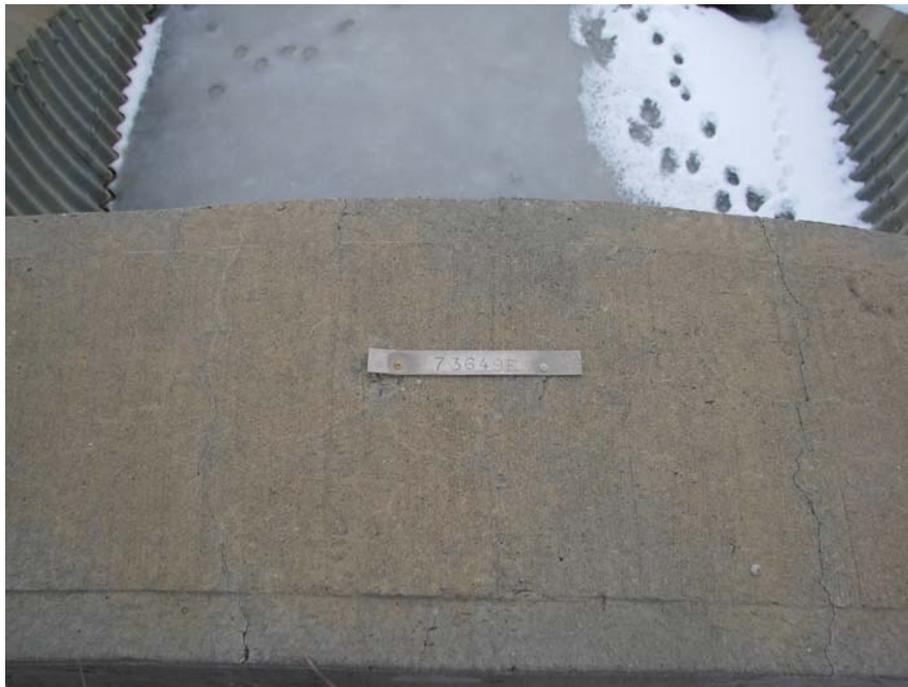
Photo: IMG_7827.JPG
Taken: 2012/11/06 10:39:37
Description: Looking down at upstream end (south end) of BF 73649E, bridgefile tag.

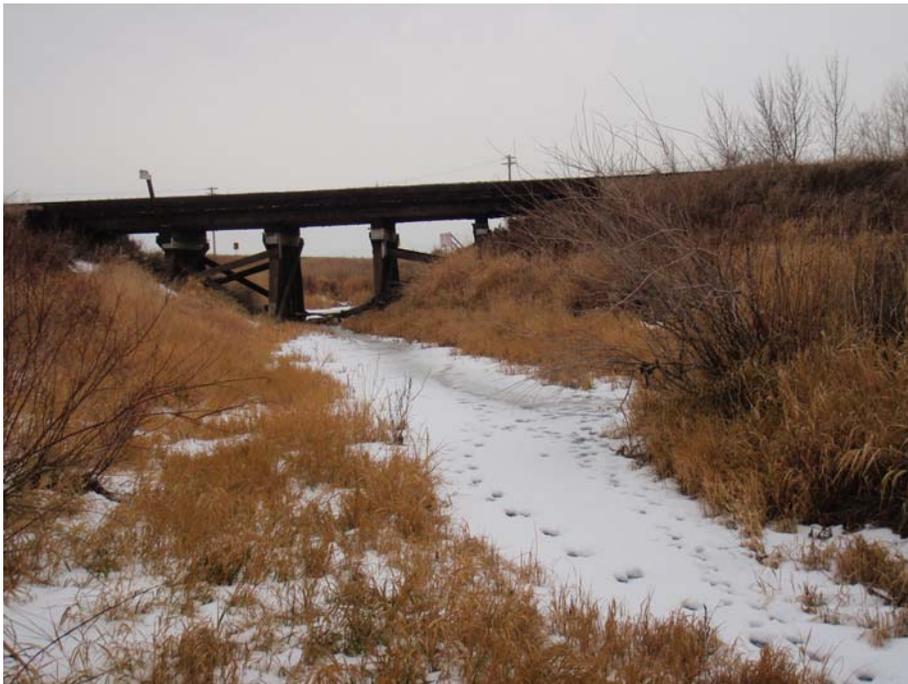
Photo: PB061520.JPG
Taken: 2012/11/06 10:02:13
Description: Looking north towards CN bridge, north (downstream) of BF 73649W.
